4627DL

**TROYKE MFG. CO. 4TH AXIS ROTARY TABLE
MODEL DL-9-B-180 OR 360**

(REFER TO ASSEMBLY DRAWING NO. 4627DL)

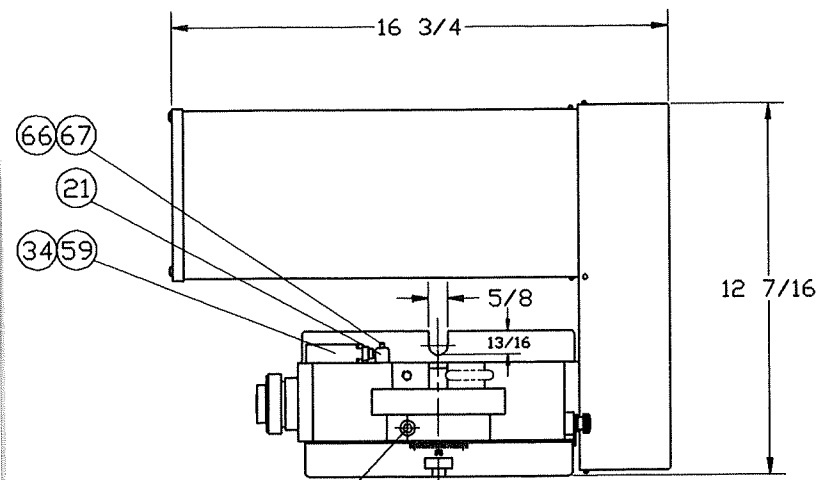
40 OIL FILL/DRAIN PLUG

LUBRICATION: THE CENTRIFUGAL CAST BRONZE ALLOY WORMWHEEL AND HARDENED AND GROUND WORMSHAFT RUN IN A BATH OF OIL AND THE BASE HAS BEEN FILLED WITH LUBRICATIONS ENGINEERS 605 ALMASOL 90 WT. GEAR LUBE OIL PRIOR TO SHIPMENT. A FILL PIPE PLUG IS PROVIDED ON THE TOP OF THE BASE. THE OIL LEVEL SHOULD BE CHECKED AT THE OIL LEVEL GAUGE LOCATED ON THE SIDE OF THE BASE TO FILL THE UNIT UN-THREAD THE CAP OF THE OIL LEVEL GAUGE AND FILL THE UNIT UNTIL OIL STARTS TO FLOW FROM THE OIL LEVEL GAUGE. SECURELY TIGHTEN THE CAP ON THE OIL LEVEL GAUGE WHEN THE TABLE IS FILLED. TO DRAIN THE UNIT REMOVE THE OIL FILL PIPE PLUG, OPEN THE OIL LEVEL GAUGE AND CAREFULLY INVERT THE UNIT. PERIODICALLY, DEPENDING UPON USAGE (SINGLE SHIFT OPERATION USUALLY EVERY 6 MONTHS / MORE THAN ONE SHIFT A DAY USUALLY EVERY 3 MONTHS), THE OIL SHOULD BE CHANGED USING 605 ALMASOL OR A GOOD GRADE OF 80 OR 90 WT. GEAR LUBE OIL. THE CENTER BEARINGS HAVE BEEN PACKED WITH GREASE AND NEED NO OIL. REPACK THE BEARINGS IF DISASSEMBLY OCCURS OR IF THERE IS MOISTURE IN THE UNIT. THE WORMSHAFT BEARINGS RUN IN A BATH OF OIL. REFER TO THE M.S.D.S. REPORT FOR FURTHER INFORMATION ON THE OIL IN THE UNIT. SOME OIL MAY SEEP OUT BETWEEN THE TURNTABLE AND THE BASE. THE REASON FOR THE LEAKAGE IS THAT WHEN THE TABLE IS RUNNING OIL WILL SPLASH UP ONTO THE TURCITE BEARING SURFACE MOUNTED BETWEEN THE TURNTABLE AND BASE TO LUBRICATE IT. THIS OIL SEEPAGE IS NORMAL. NOTE: DO NOT OVERFILL UNIT OR THE OIL SEEPAGE MAY INCREASE.
